EFFECTS OF GEOLOGICAL STRUCTURES ON TUNNEL EXCAVATION AND IMPROVEMENT WORKS AT KIZLAÇ TUNNEL ON TARSUS-ADANA-GAZIANTEP MOTORWAY

Zuhal ETKESEN¹, Yavuz ERGINTAV², Nefise AKÇELİK¹, Hikmet TUĞLU³

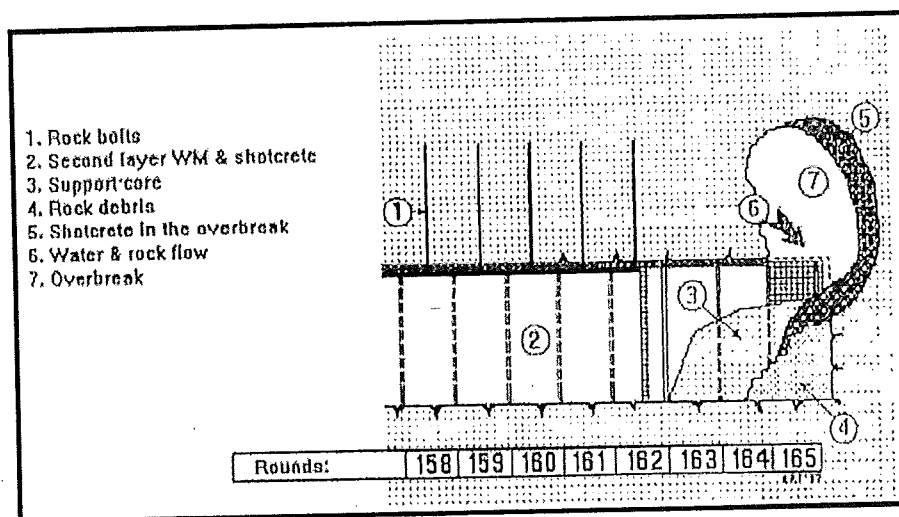
On October 11, 1995; from the right side of the crown of Round 165, the ground fell down and an overbreak chimney of 12 m³, occurred (Fig.3). Overbreak volume stabilized within three meters above the tunnel Crown. The collapse occurred while approaching the fault gouge with C2 rock class between Km: 41+831 and 41+840.

Figure 3: First collapse in Round 165

During removal of the rebound material, small but steady trickle of loose material began flowing into the tunnel from the right shoulder and from the back face of the cavity. Finally, there occurred a flood with rapidly increasing volume. Tunnel collapsed at the area indicated by 6 in the above figure (between rounds 163-169). The volume of flowing material was 650 m^3 , the flow rate of water was 25 lit/sec, respectively.

As an immediate measure for this situation, support was reinforced with extra mesh and shotcrete and longer rockbolts were installed on the left side. The face of flowing material was given steeper slope, supported with shotcrete, mesh and face bolts, while a shotcrete arch rib was formed. Additional and continuous deformation and water flow measurements were done.

Two months after collapse, a three layer umbrella made of perforated pipes drilled and installed at varying angles from flat, to 25° and 50° to has been formed as a curtain so as to prevent flow into tunnel, over the collapsed part of tunnel. Then more holes were drilled in the crown and collapsed zone, and grouted with cement grout, while extra rockbolts of six meter long were installed between the grout holes. Excavation was made by two side-drifts at the top heading and the middle top heading. The position of old face was recovered on 5 th March 1996 five months after collapse. By this time North Tube, thirty meters away, had advanced past the South Tube without any problem.

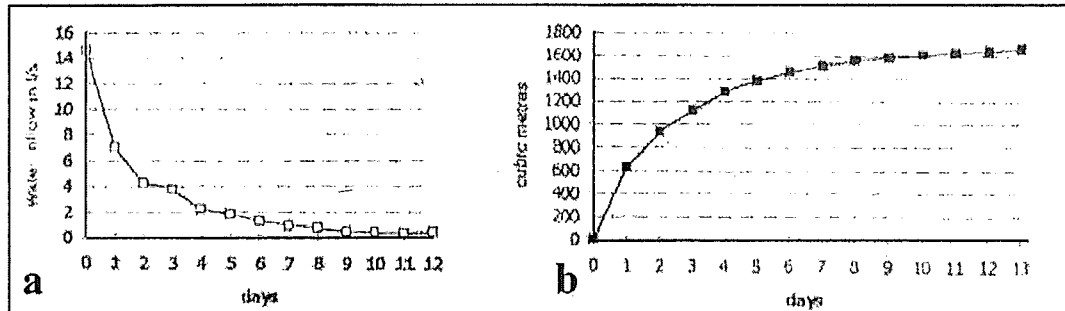
The final collapse started from the face at the right side of the heading and then extending to the full face. The initial water inflow was about 25 lit/s (estimated), decreased to less than 3 lit/s within 4 days and less than 0.5 L/s within 10 days. (Fig.4).

Figure 4: Second collapse-a: water inflow rate, b:total water intake

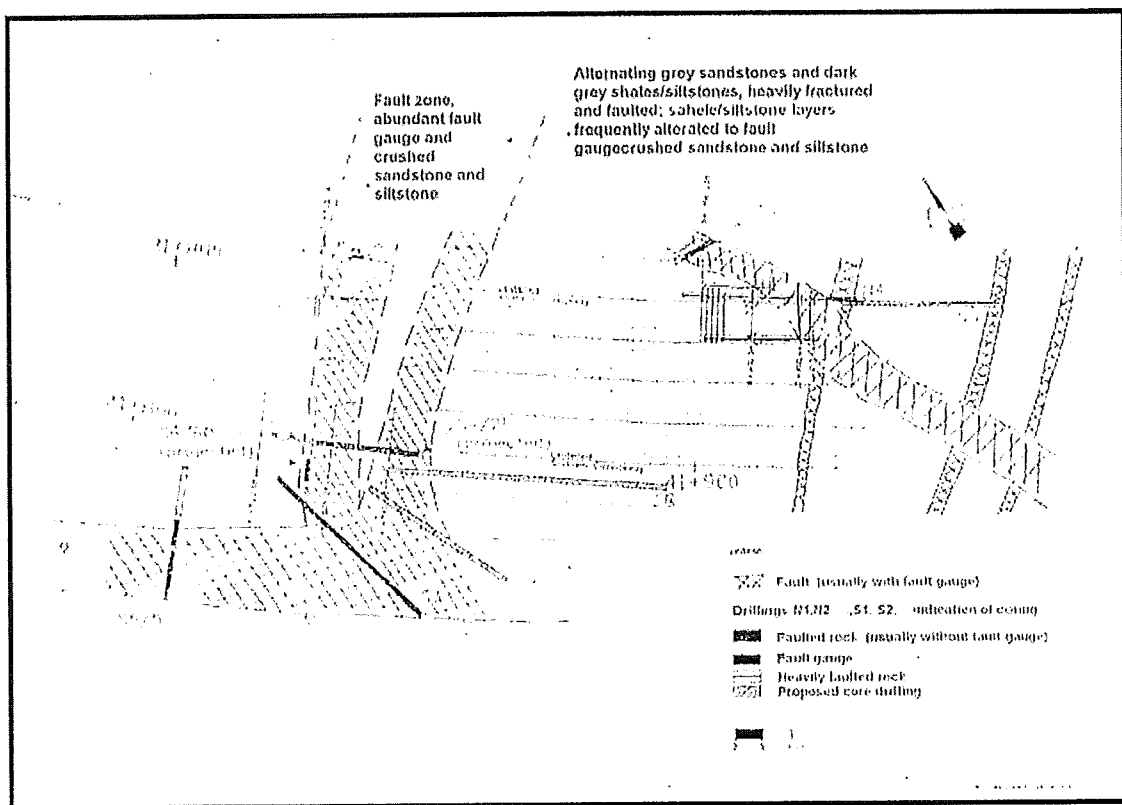
The collapses happened in an area where two secondary faults, crossing the tunnel nearly perpendicular, were joining each other and where a fault was striking parallel to the southern side wall (Fig.5). After second collapse the tunnel will be driven in fractured sandstone, and shale/siltstone and abundant fault gouge. According to boreholes in north tube, there is another fault dipping towards southern tube, in a manner to intersect the tunnel axis nearly horizontally (10^0 - 30^0) trending southeast.

At the right side, where two faults were joining asymmetric stresses occurred laterally. Seeping water accumulated in pressurized fault zone and was flowing out from weathered sandstone. The area in front of the face was not supported (only sealing shotcrete was applied). This area was also affected by additional stresses from remaining loose zone of first collapse. The rock around the tunnel and behind face (fault zone) could not sustain these stresses and failed subsequently.

Figure 5: Geological horizontal section

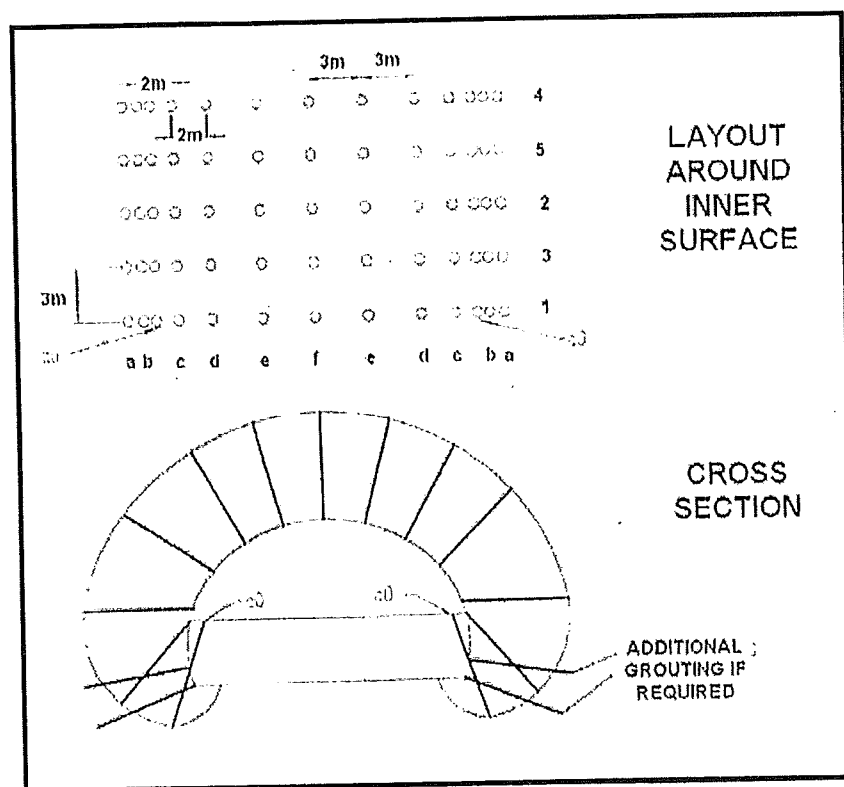
Figure 6: Layout of final grouting.

At the area affected by the collapse, a self-supporting arch with thickness of min 6 m was established by grouting. The length of arch along the tunnel profile was 18 meters. (Figure 6)

The aim of grouting was to form a consolidated arch in the loose material above the tunnel crown with a minimum thickness of 6 m, in order to be able to advance through the collapsed area. The first grouting sequence covered a length of 18 meters. But according to data obtained from forepoling and bolt drillings some additional grout works were done where required. Perforated pipes around the periphery in the flattest possible angle at 30 m spacing were installed. Forepoling pipes diameter 2", for a length of 18 m was used.

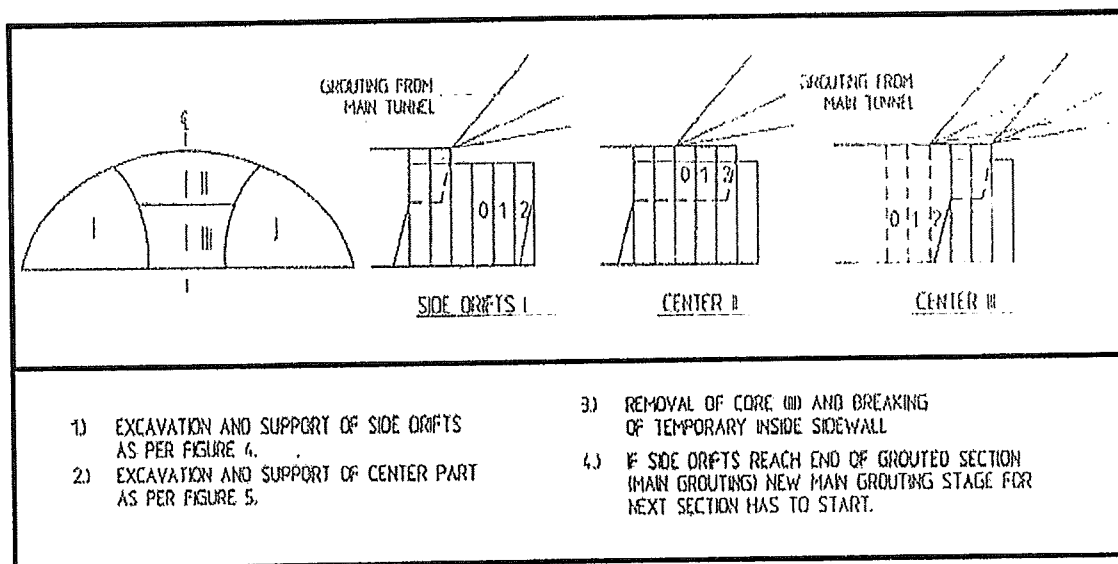
Figure 7: Excavation sequence; side drifts and center

The loose material in the tunnel was stabilized, a new face was cut and the face bolts were installed. Advance in the collapsed area is provided by application of two side drifts based on rock class 6, till undisturbed rock mass ahead of the previous face. (Figure 7)

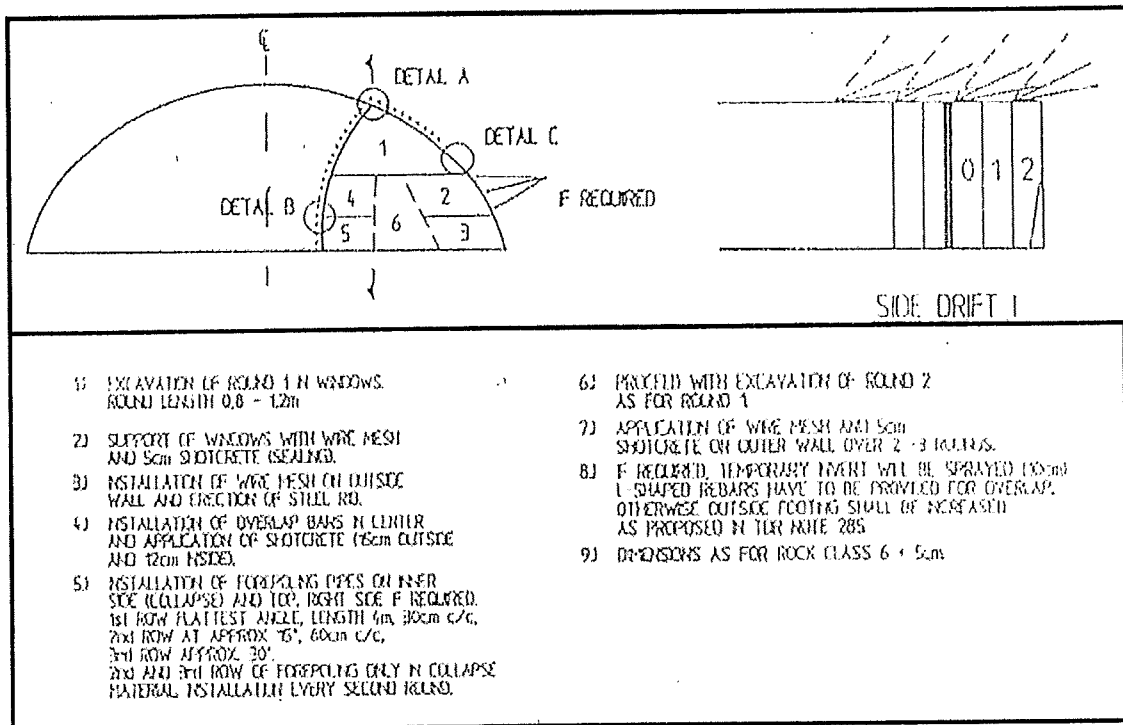
Figure 8: Excavation sequence; side drifts

When the center (middle) part of the side drift advance reached 3-4 rounds in undisturbed rock mass, excavation was stopped and shotcrete and rock bolts were completed. (Figure 8,9)

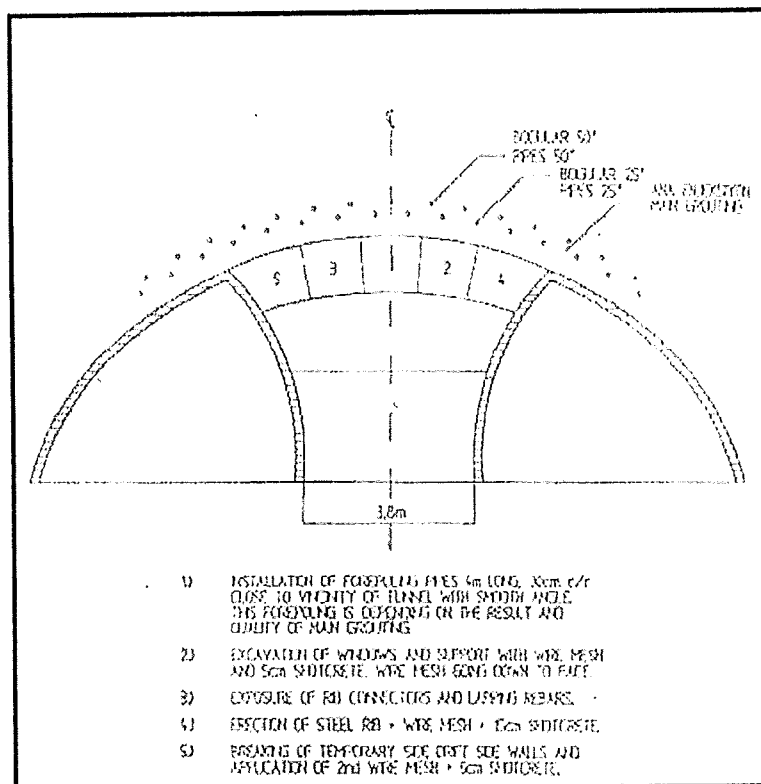
Figure 9: Excavation of center
