REHABILITATION OF DORUKHAN TUNNEL

ABSTRACT

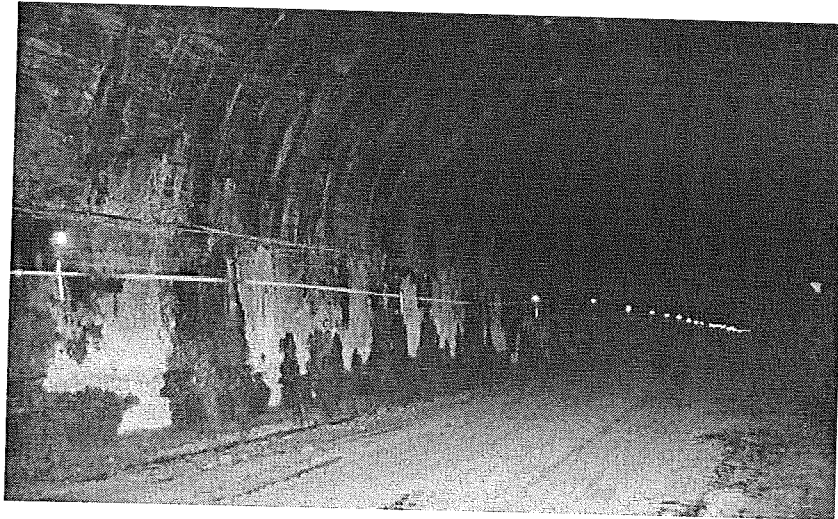
Dorukhan Tunnel, with 903 m length, is located on a main road which links Ankara, capital of the Turkey, to Black Sea. Construction of the tunnel was completed by conventional methods in difficult geological conditions and opened to traffic in 1976. The permanent support of the tunnel was concrete lining with a quality of BS 16. Due to lack of water insulation, there was water inflow towards the tunnel especially at the conjunction of the main tunnel and cut-and-cover section of the tunnel. Concrete lining and pavement were heavily damaged; illumination and ventilation systems could not be established (Figure 1).

Figure 1 The Inside of the Tunnel Before Rehabilitation

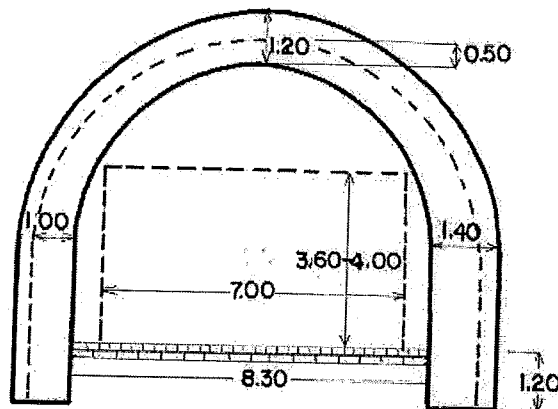
According to the original design, thickness of the concrete lining was 50 cm at crest, 100 cm at sidewalls in sections of tunnel driven in granodiorite and 120 cm at crest, 140 cm at sidewalls in metasiltstone. The thickness of the pavement was 27-30 cm concrete lining overlaid by cobblestone. Vertical clearance in the traffic area, 3.60-4.00 m, was low and out of standards (Figure 2). Traffic speed was decreased up to 15-25 km/h. During the initial construction, thicknesses of the lining were revised due to problems encountered during excavation of the tunnel but there were no records about construction. Considering location of tunnel, traffic volume and length of tunnel, rehabilitation of the tunnel was a necessary.

Figure 2. Crossection of the Tunnel Before Rehabilitation
(—Concrete lining in phyllite-metasiltstone, ---Concrete lining in granodiorite)

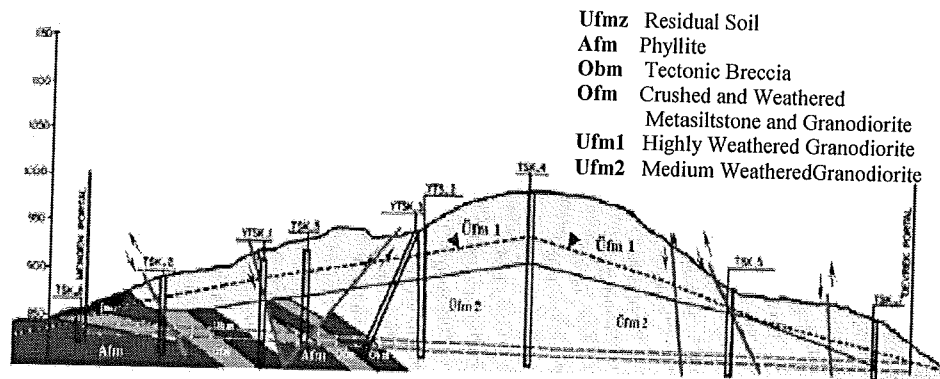
Tunnel location is near North Anatolian Fault Zone and was driven in phyllite - metasiltstone and granodiorite which are poor and weathered rock. There was fault gouge with low angle due to overlaying of granodiorite to phyllite and metasiltstone that governs tunnel geology about 350 m in length at Mengen side. This section was defined as class C2 (squeezing) and remaining 550 m in length at Devrek side was defined as class B2 (friable), according to New Australian Tunnelling Method (NATM) (Figure 3).

Figure 3 Geological Profile of the Tunnel

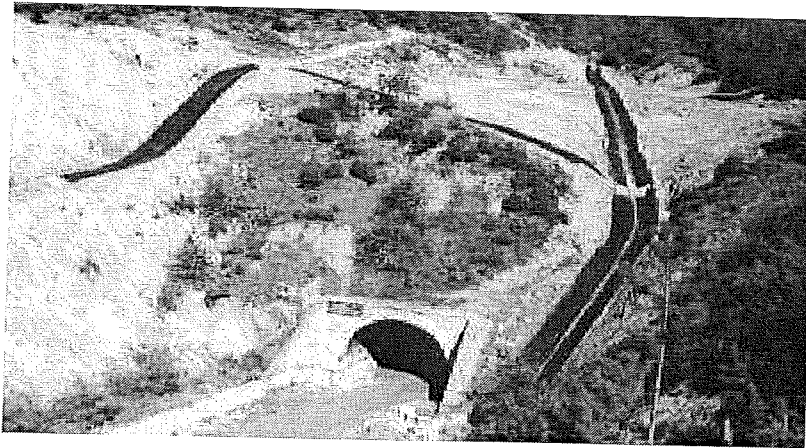
Figure 4 Surface Drainage on the Mengen Portal

As it was mentioned before, there was water inflow towards the tunnel. Water inflow through the tunnel was reduced by establishing surface drainage with concrete lining trenches in portals of tunnel (Figure 4).

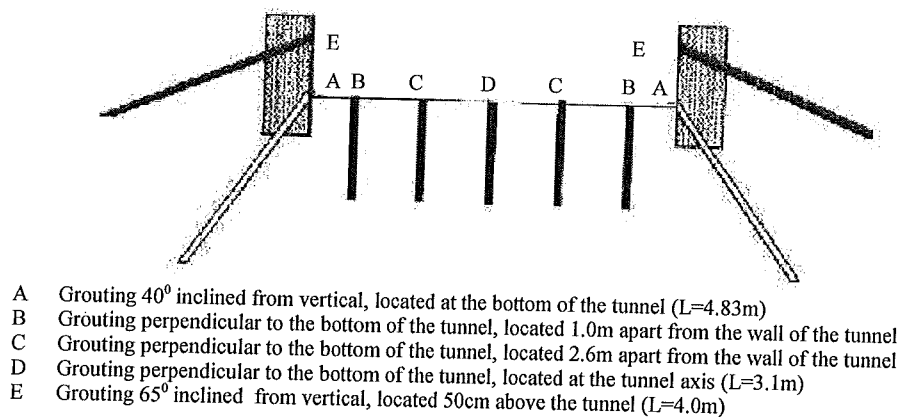
Figure 5 Section of Grouting Holes at the Bottom

In order to evaluate the performance of grouting, trial of grouting was performed in three sections having different characteristic. First part was between Km:0+000 and 0+024 and having a formation of phyllite-metasiltstone, second part was between Km:0+560 and 0+584 and having a formation of granodiorite and last part was between Km:0+850-0+874 at cut-and-cover section. Control tests were performed in order to check the results according to Specifications of State Hydraulic Works. Then, it was concluded that by grouting a reasonable improvement at the tunnel bottom could be maintained (Figure 5). The depth of the groutings (B,C,D) at the tunnel bottom was increased in order to obtain a deeper grouted ring in highly weathered rock conditions.

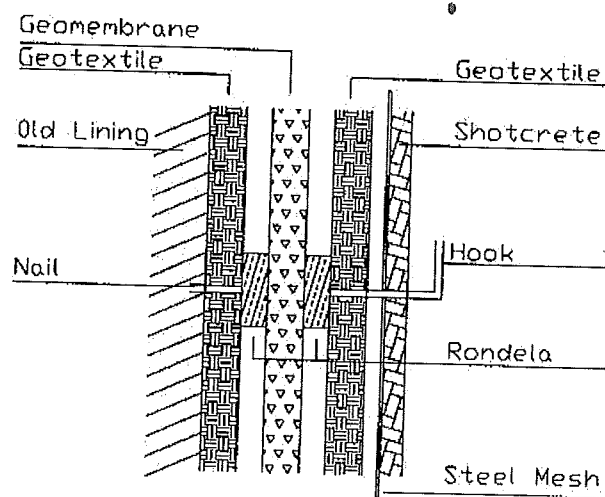
Figure 6 Waterproofing Details

In trial application, rondela with hook was applied on membrane, steel mesh was hanged on hook and shotcrete was spread on steel mesh. After the trial, application waterproofing system was redesigned and steel bars were put in front of the steel mesh to prevent hanging down. Waterproofing and shotcrete application were performed along the tunnel according to the details given in Figure 6.

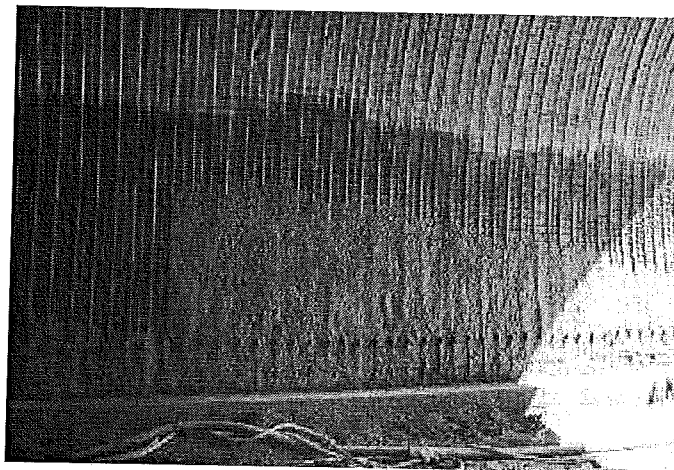
Figure 7 Steel Mesh and Shotcrete Application

Shotcrete was applied on steel mesh, which was reinforced with Ø12 bars bent in radial direction with 0.2 m spacing (Figure7).

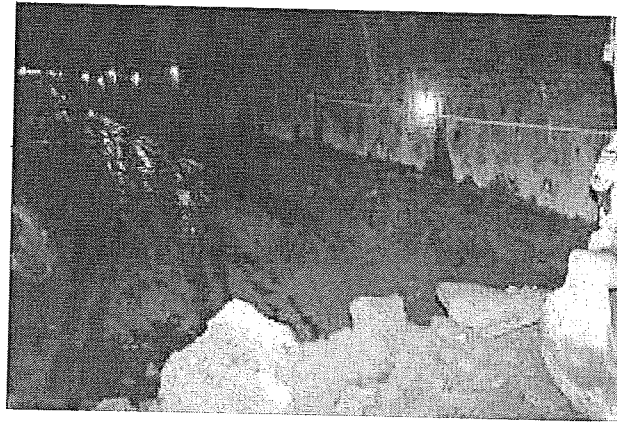
Figure 8 Excavation at the Tunnel Bottom with 3-D Measurement

Drainage holes, which were 6m in length and 5 cm in diameter, were drilled in the existing lining and PVC pipes were set in these holes. After the bottom of the tunnel had grouted, the material at the bottom of the tunnel was excavated. During the excavation process, 3-D geotechnical measurements of lining were performed in order to control unexpected deformations (Figure 8).

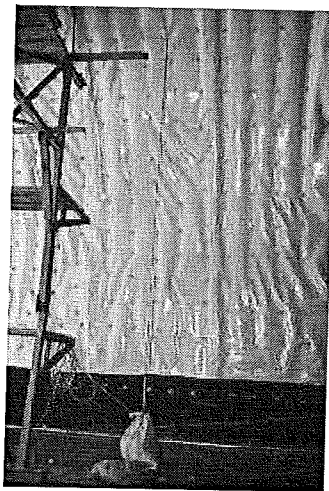
Figure 9 Application of Waterproofing

In the following stage, waterproofing was applied according to revised application details (Figure 9). Steel mesh and shotcrete lining were applied (Figure 7). Before the construction of final pavement, surface drainage and cable channels were located (Figure 10).

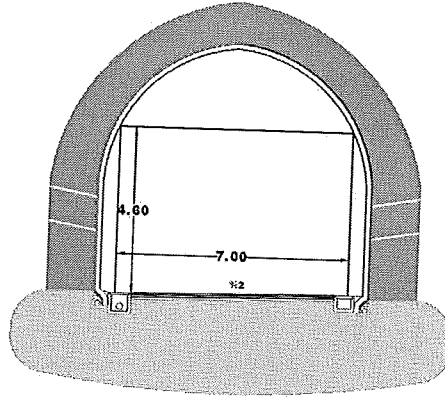
Figure10 Cross-section of Dorukhan Tunnel after Rehabilitation
