# SENSKIN

## BRIDGE MONITORING IN THE UNITED KINGDOM

Peter Jones, TRL

Senskin 2<sup>cd</sup> Workshop, İstanbul, 24-25.May.2018

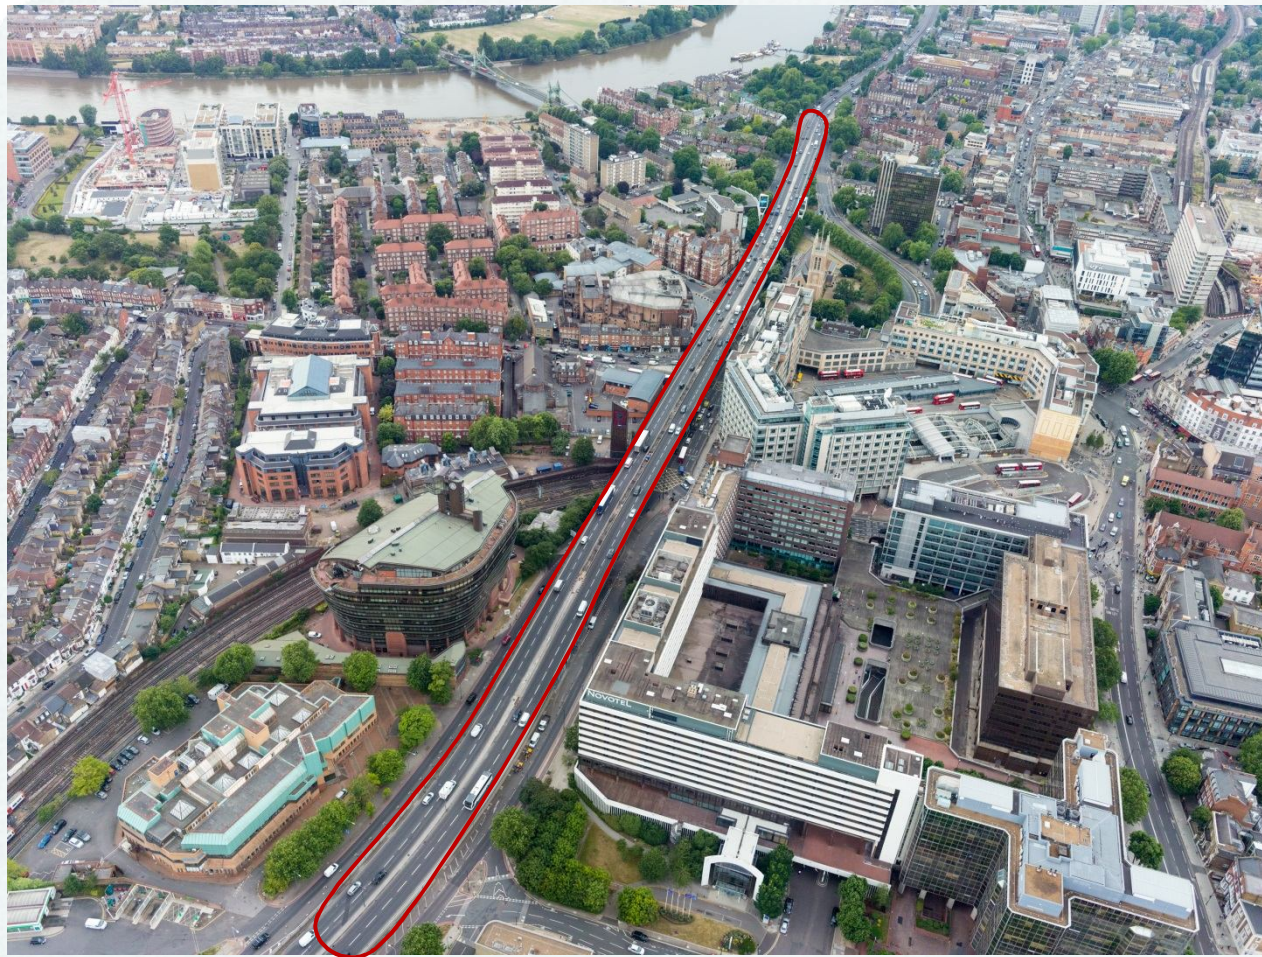
# Hammersmith Flyover: Overview

- 622m elevated length
- 16 spans
- 4 lanes

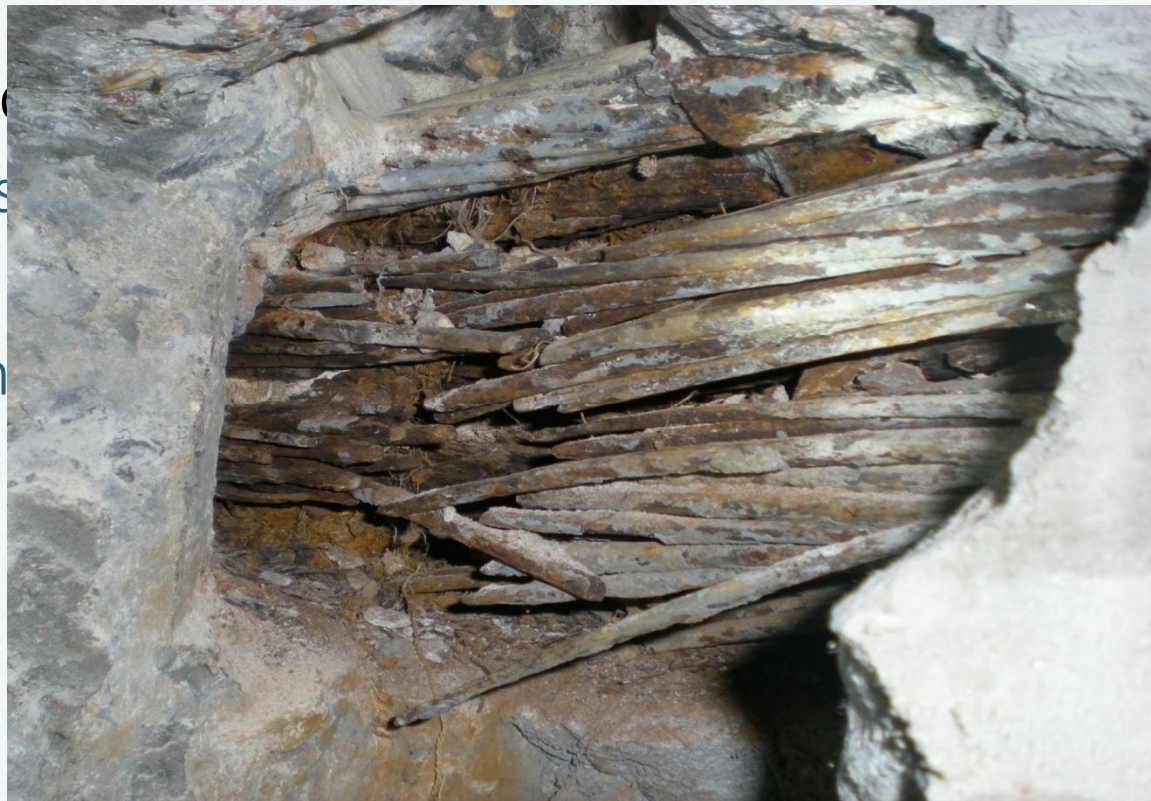
# Hammersmith Flyover: Problem

- Water ingress (with salt) through the deck has been a problem
- Tendons are not protected
  - Steel tendons
  - Each tendon
  - Some wires have

- Tendons are encased in grout: impossible to see
- Wire breaks are impossible to locate retrospectively
- Number of wires broken is critical to understanding capacity of structure = safety
- Interim solution: Structural health monitoring

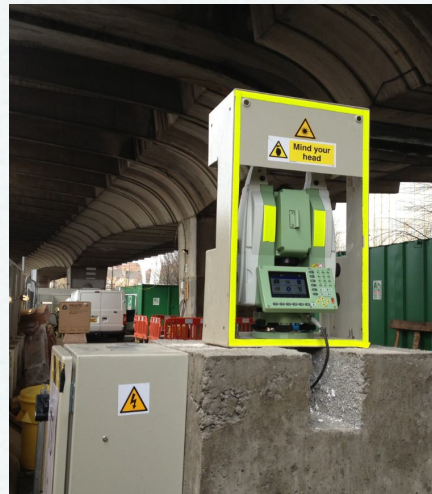
# Bridge deflection monitoring

- Additional monitoring of the displacement of the mid-spans
- Use of total stations to detect out-of-range deflections

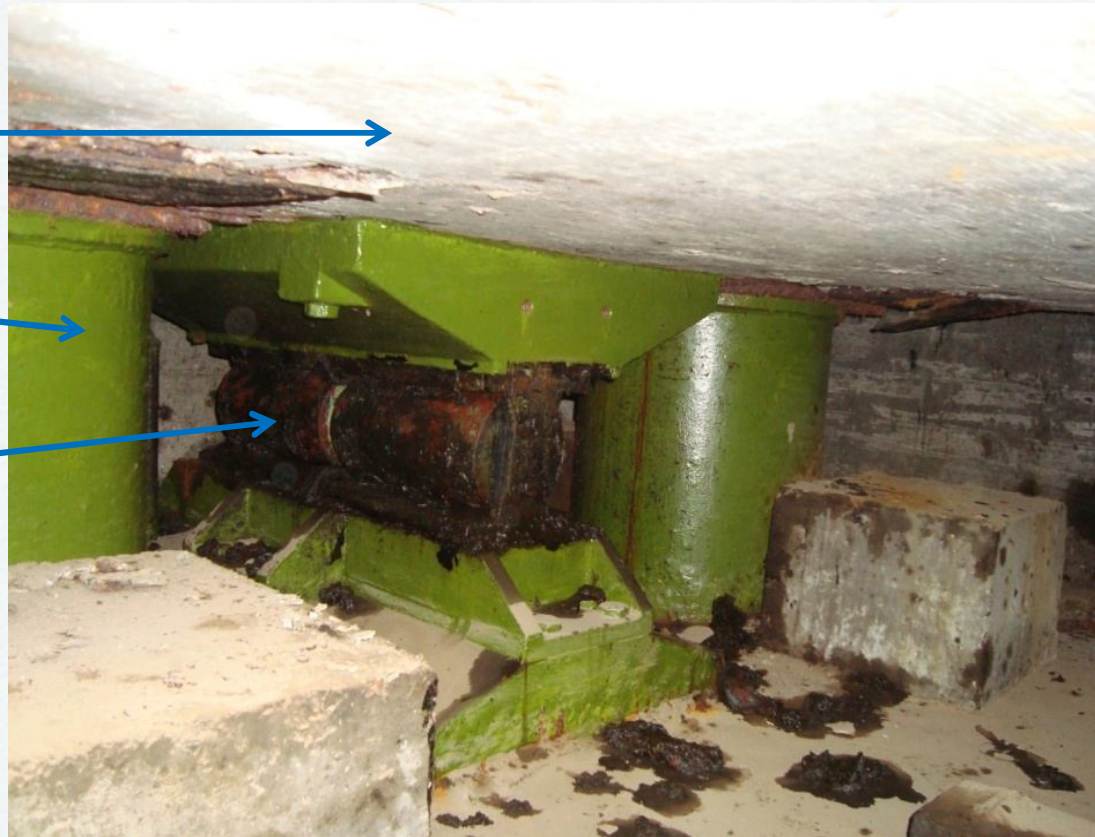
# Hammersmith Flyover: Bearings

Bridge pier →

Fail-safe stool →

Roller bearing →

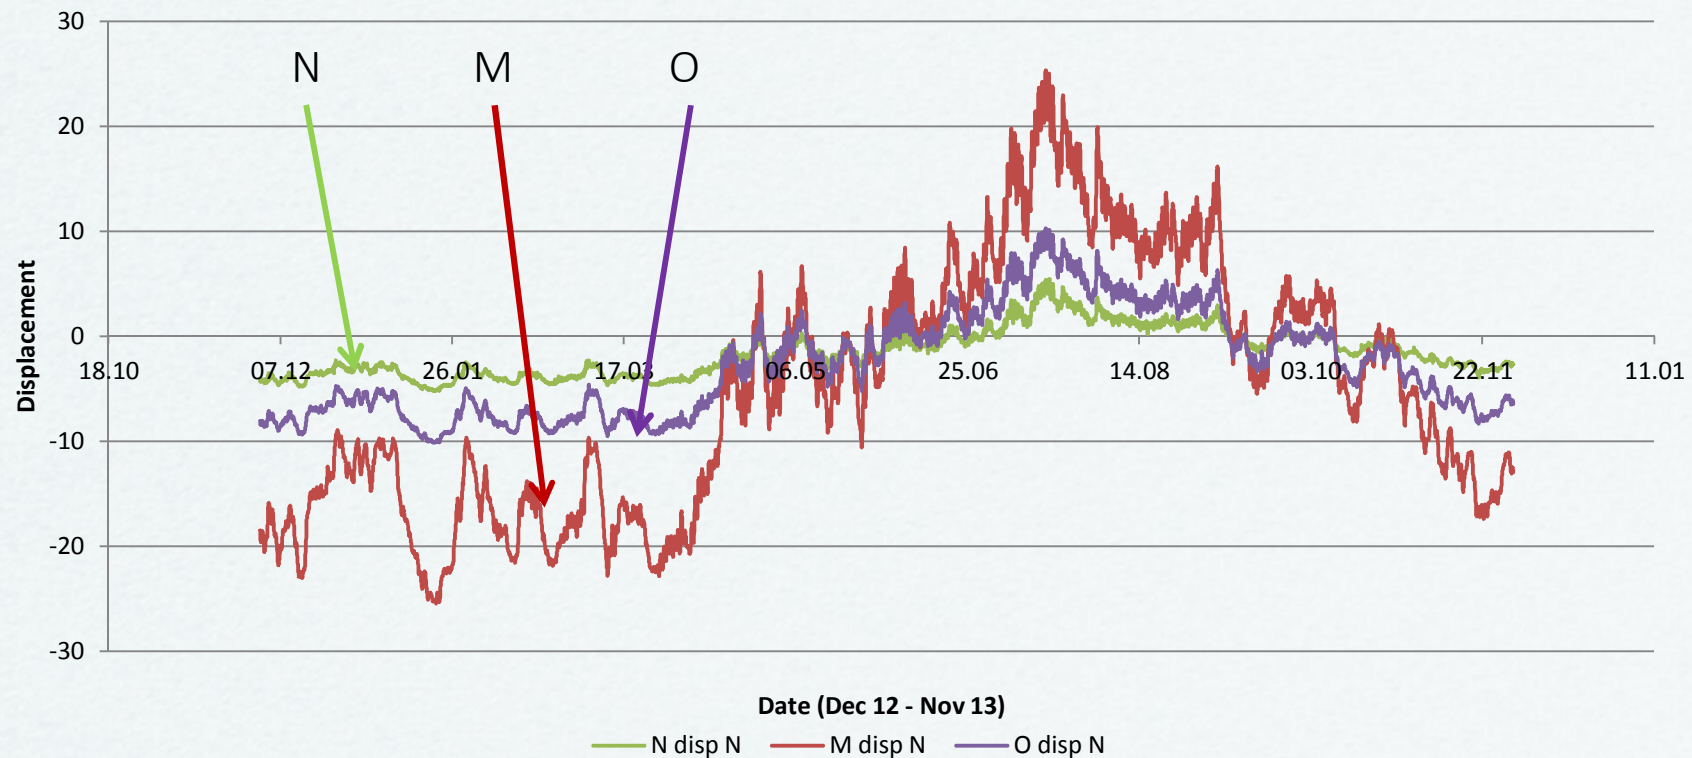
# Hammersmith Flyover: Bearings

- Bearing displacement

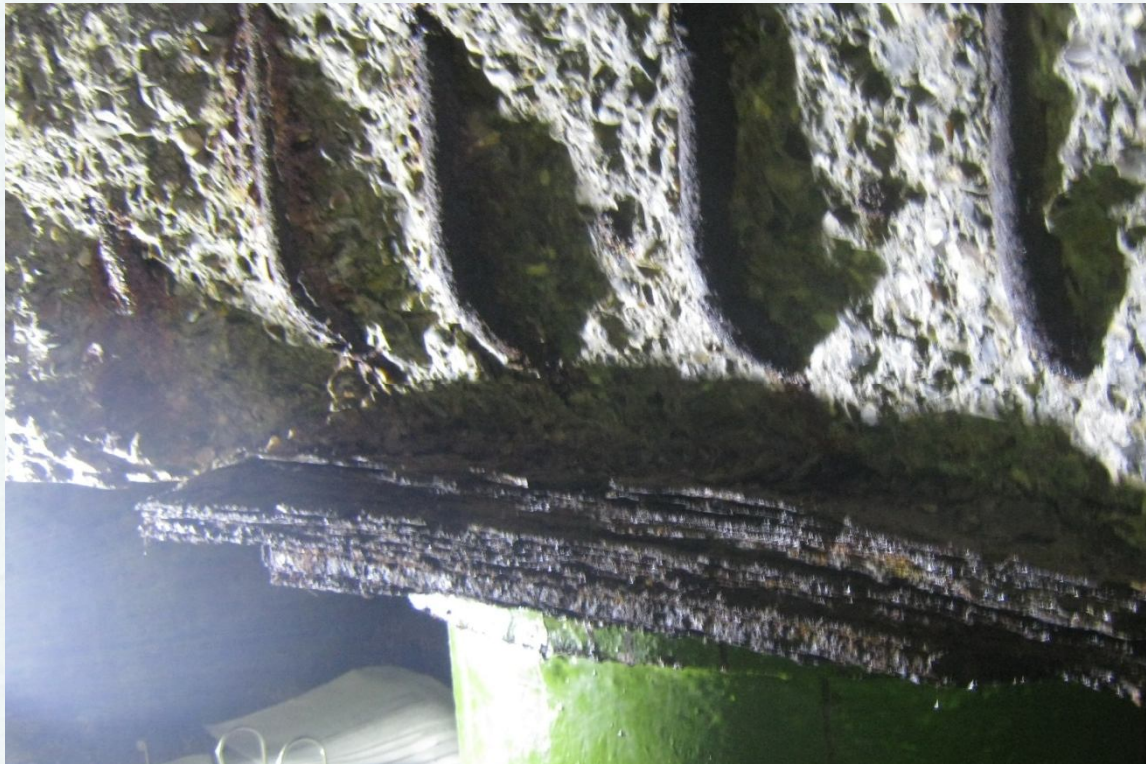
# Hammersmith Flyover: Bearings

- Pier 'N' was stuck on its fail-safe stool due to corrosion caused by flooding of the bearing pit

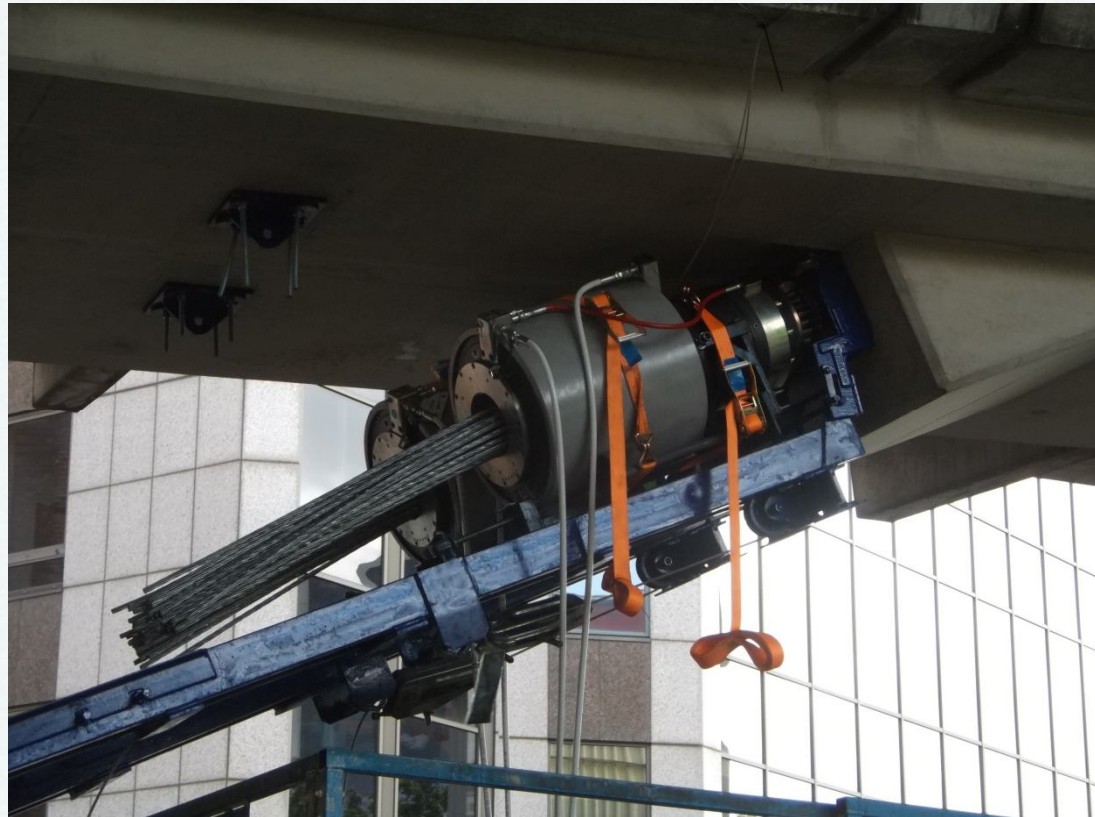
# Hammersmith Flyover: Construction

- Local strain monitoring during construction

37 strands of 7 wires  
stressed to  $>1000\text{MPa}$

Strain gauges measure  
local effects of force  
transfer to structure

Bearing monitoring  
measures global effect  
of force transfer
