EFFECTS OF GEOLOGICAL STRUCTURES ON TUNNEL EXCAVATION AND IMPROVEMENT WORKS AT KIZLAÇ TUNNEL ON TARSUS-ADANA-GAZIANTEP MOTORWAY

Zuhal ETKESEN¹, Yavuz ERGINTAV², Nefise AKÇELİK¹, Hikmet TUĞLU³

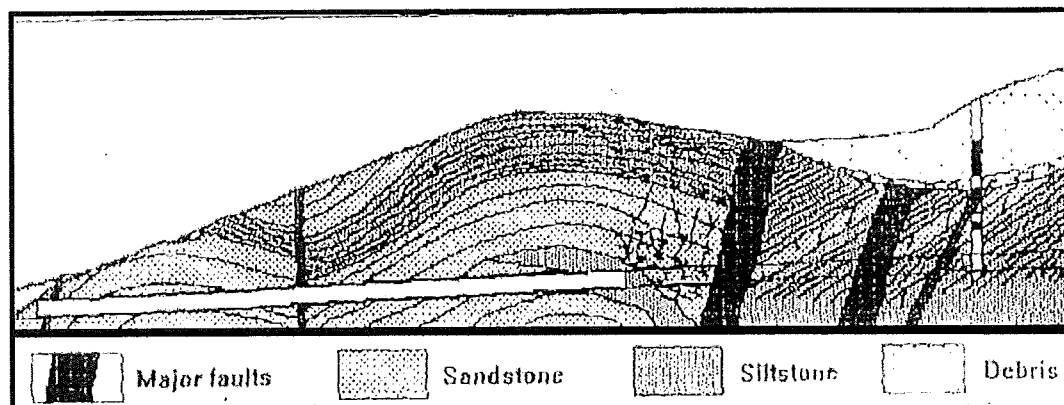
excavated in rock formations consisting sandstone, siltstone and shale with zones of crushed and weathered material (Figure 1). During excavation a lot of fault zones of varying thickness (5-30 m) have been encountered and collapses occurred at some of these zones, which were not predetermined in the field works and design phase.

Figure 1: Longitudinal section showing geology
