REHABILITATION OF DORUKHAN TUNNEL

ABSTRACT

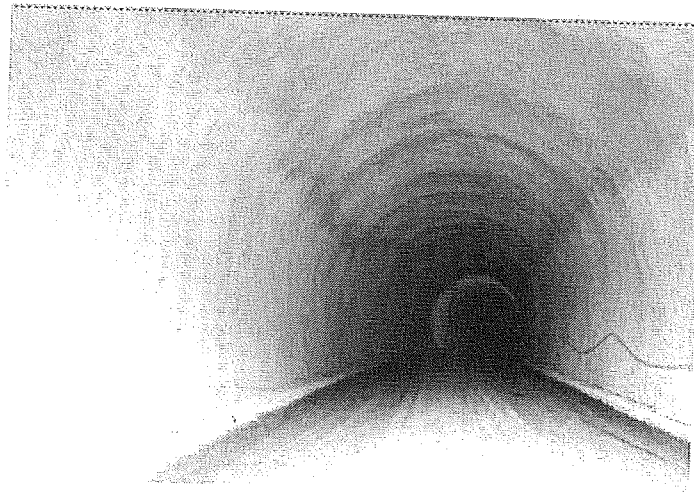
Figure 11 A View from Dorukhan Tunnel after Rehabilitation

Dorukhan Tunnel, located on the main artery, had to be opened to traffic during winter season since the service road with low geometric standards could not serve traffic. So, the rehabilitation works has been carried out for two-summer seasons. Rehabilitation of the tunnel was started on October,1998 and completed on November, 2000 (Figure 11). During rehabilitation works, 37,894 m² protective felt (geotextile), 18,947 m² membrane, 78 tones steel mesh, 185 tones reinforcement, 2,518 m³ shotcrete, 2,118 m drainage pipe and 17,976 m³ pavement material were used. The estimated cost was 4,692,820USD excluding service road cost. Due to auditing in construction, the final cost is reduced to 4,116,944 USD including the cost of service road.
